# METEOROID AND DEBRIS IMPACT FEATURES DOCUMENTED ON THE LONG DURATION EXPOSURE FACILITY

## A Preliminary Report

Compiled by Members  
of the LDEF Meteoroid  
and Debris Special  
Investigation Group

August 1990

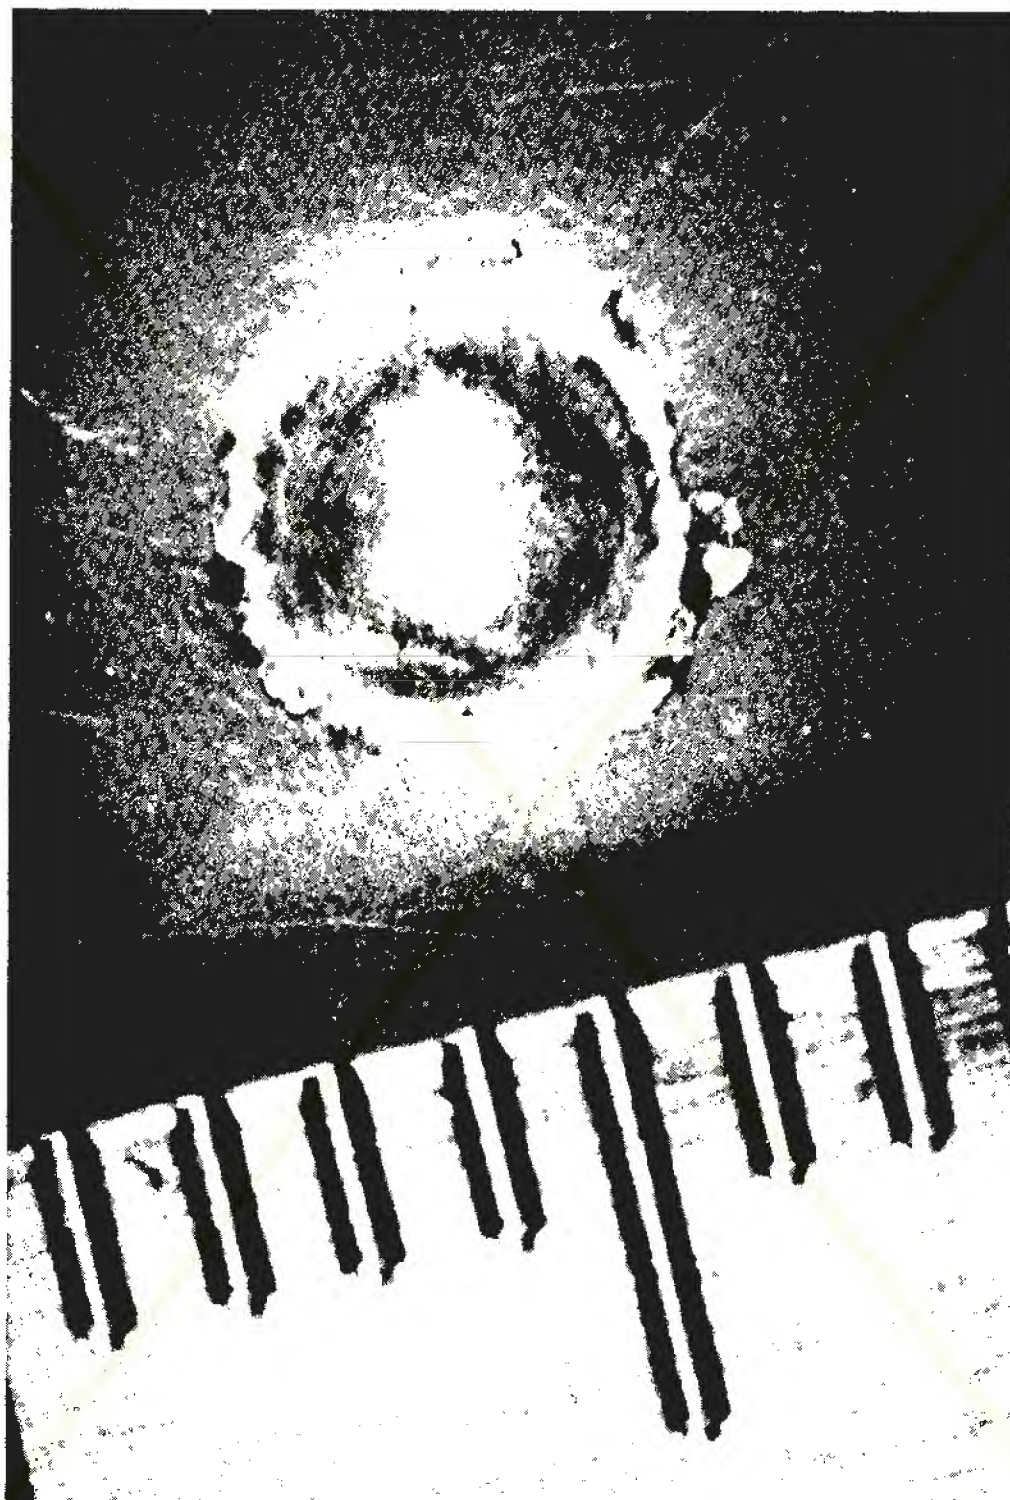
**Figure 2.** Photograph of a symmetrically-shaped crater in an aluminum surface. Most features on LDEF were of this type. Small divisions on scale are in millimeters.

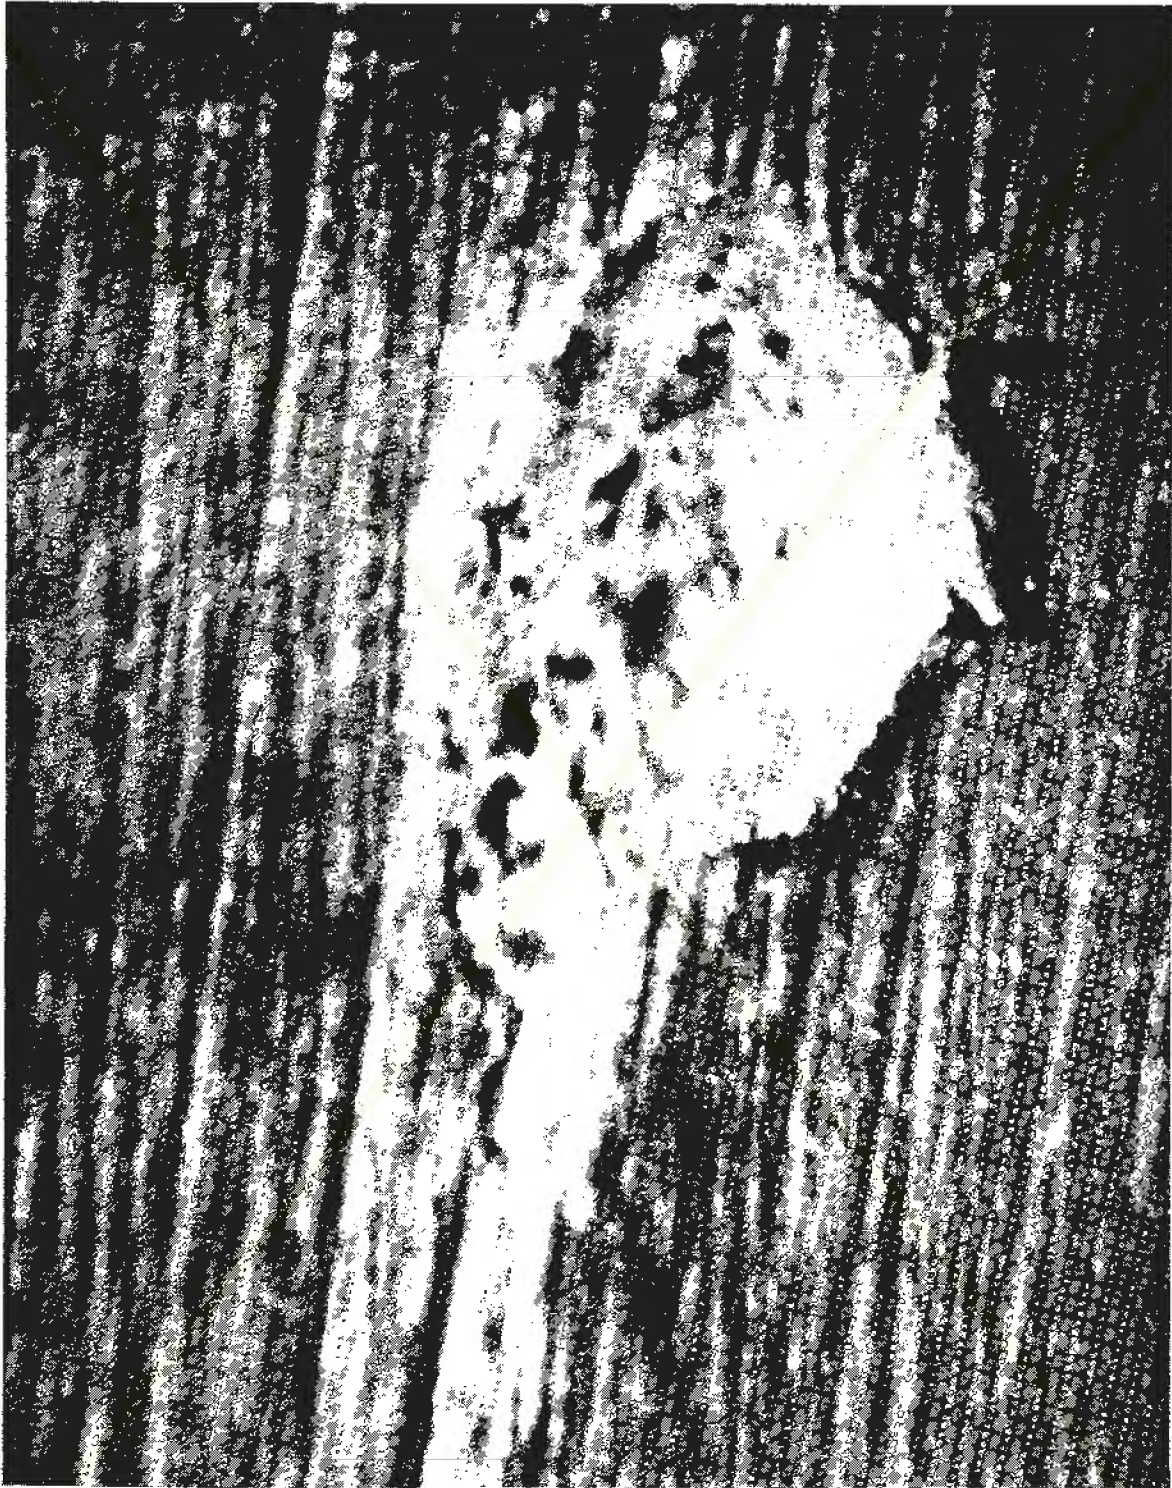
**Figure 5.** Photograph of an elongate feature in an aluminum surface, probably from an extremely low-angle ( $<5^\circ$ ) or oblique impact. View measures approximately 1.5 cm across.

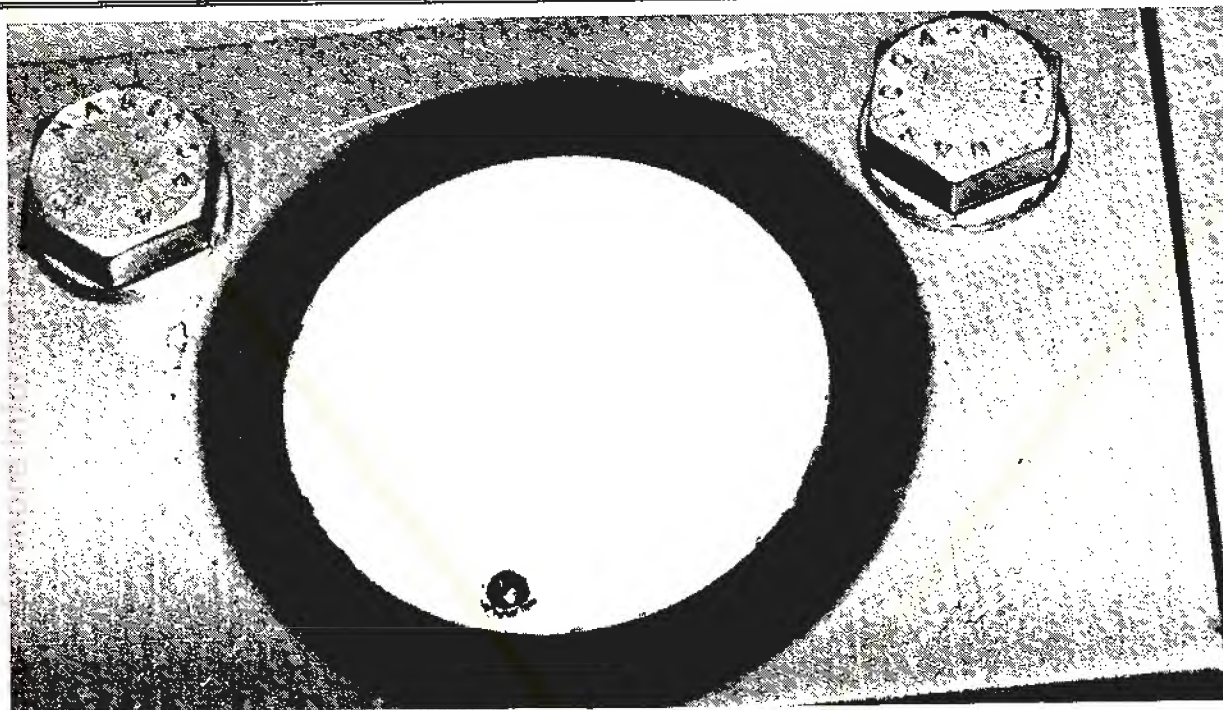
Figure 9. Impact into one of the paint specimens on an experiment-tray clamp. This particular feature was the largest impact feature found on the numerous tray clamps. View measures approximately ~6.5 cm across.

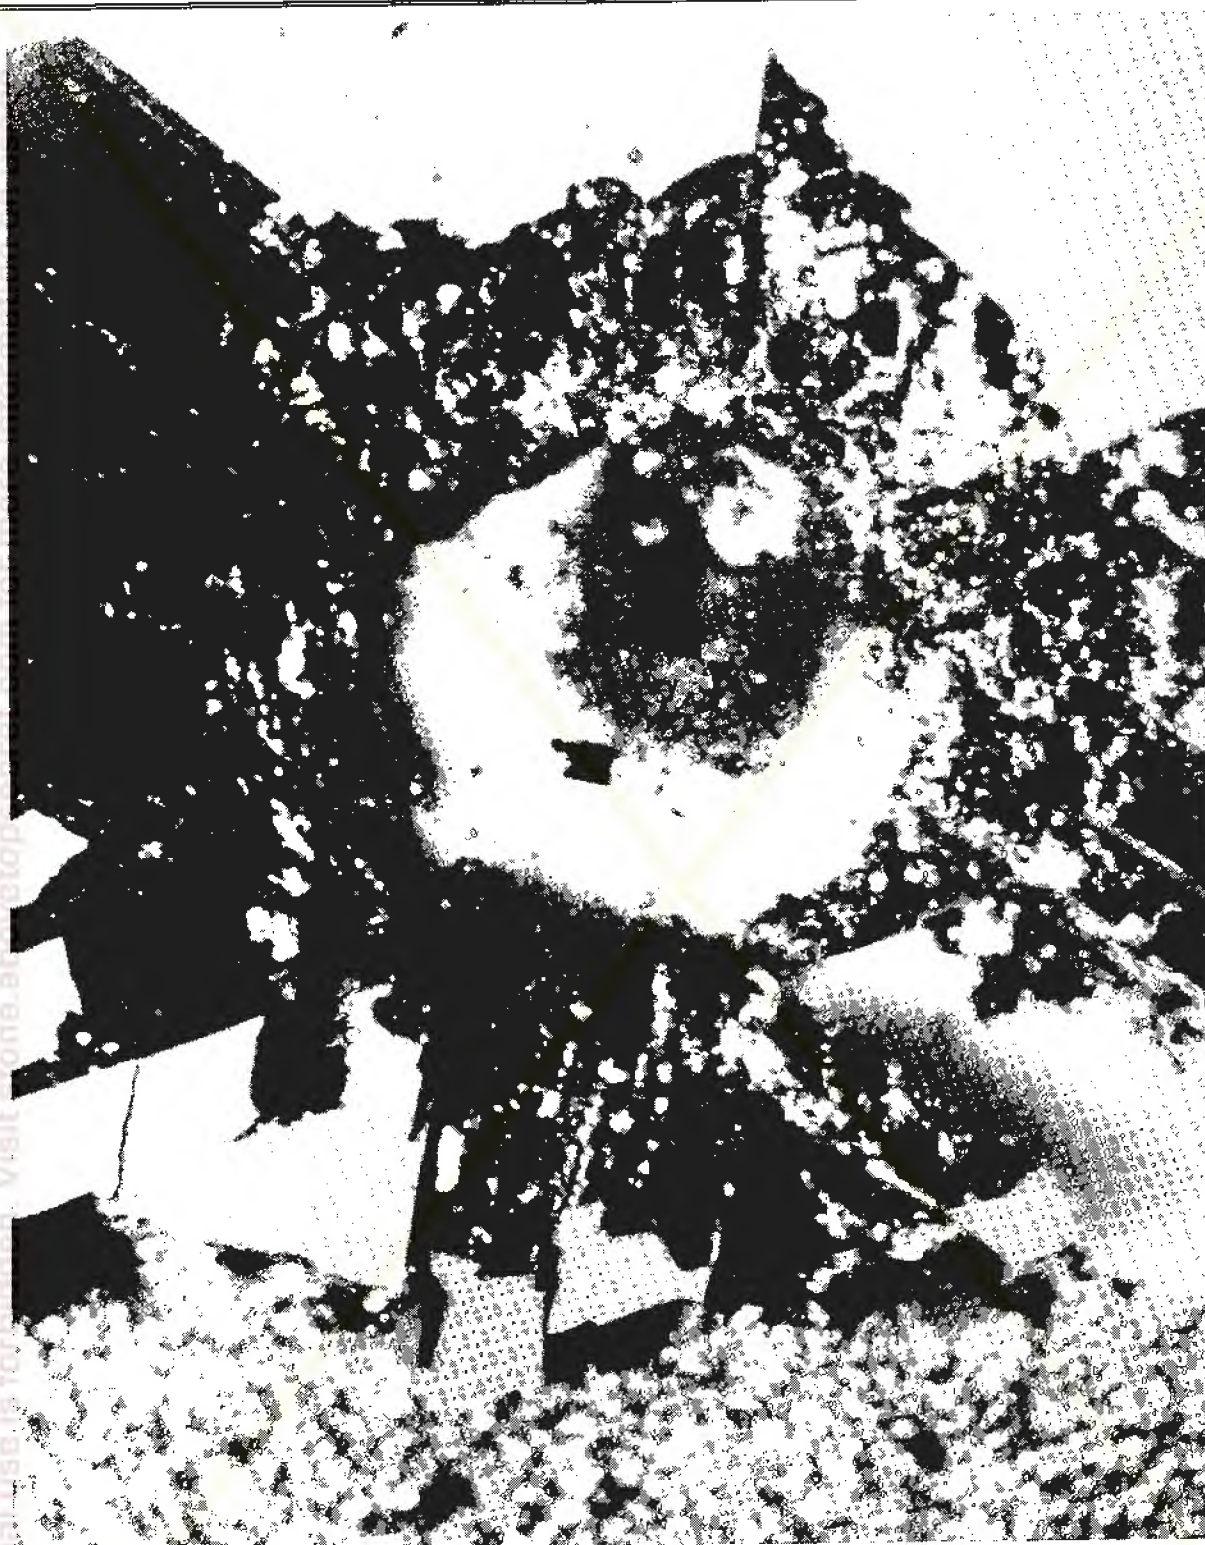
Figure 11. Photograph of an impact feature in one of the metal-oxide-silicon (MOS) detectors of the Interplanetary Dust Experiment (A0201; Bay B12). A central penetration hole (arrowed) is surrounded by a crater and extended fracture zone. View measures approximately 1 mm across. The same feature at a lower magnification can be seen in Figure B12-2.

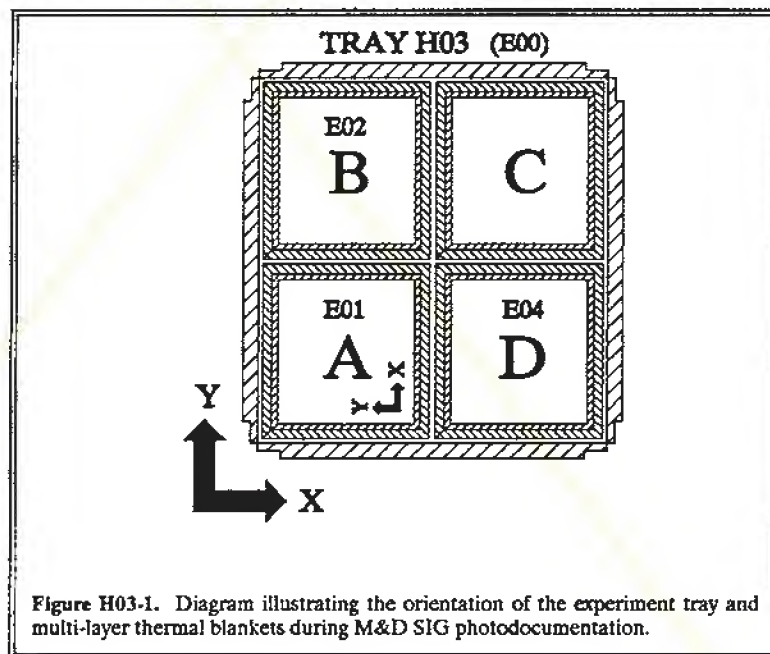
back on orbit, impact features were apparent in the lexan detector stacks. Some impact features were accompanied by cracks (e.g., Detector "D"). No impacts were noted in the portions of the lexan detectors which were still shielded by the multi-layer blankets.
